# Precinct 2 Concept Design: Teralba Rd (Brighton-Le-Sands) to Solander St (Monterey)

## LADY ROBINSONS FORESHORE MANAGEMENT PLAN

Report MHL3034

Prepared for: Bayside Council

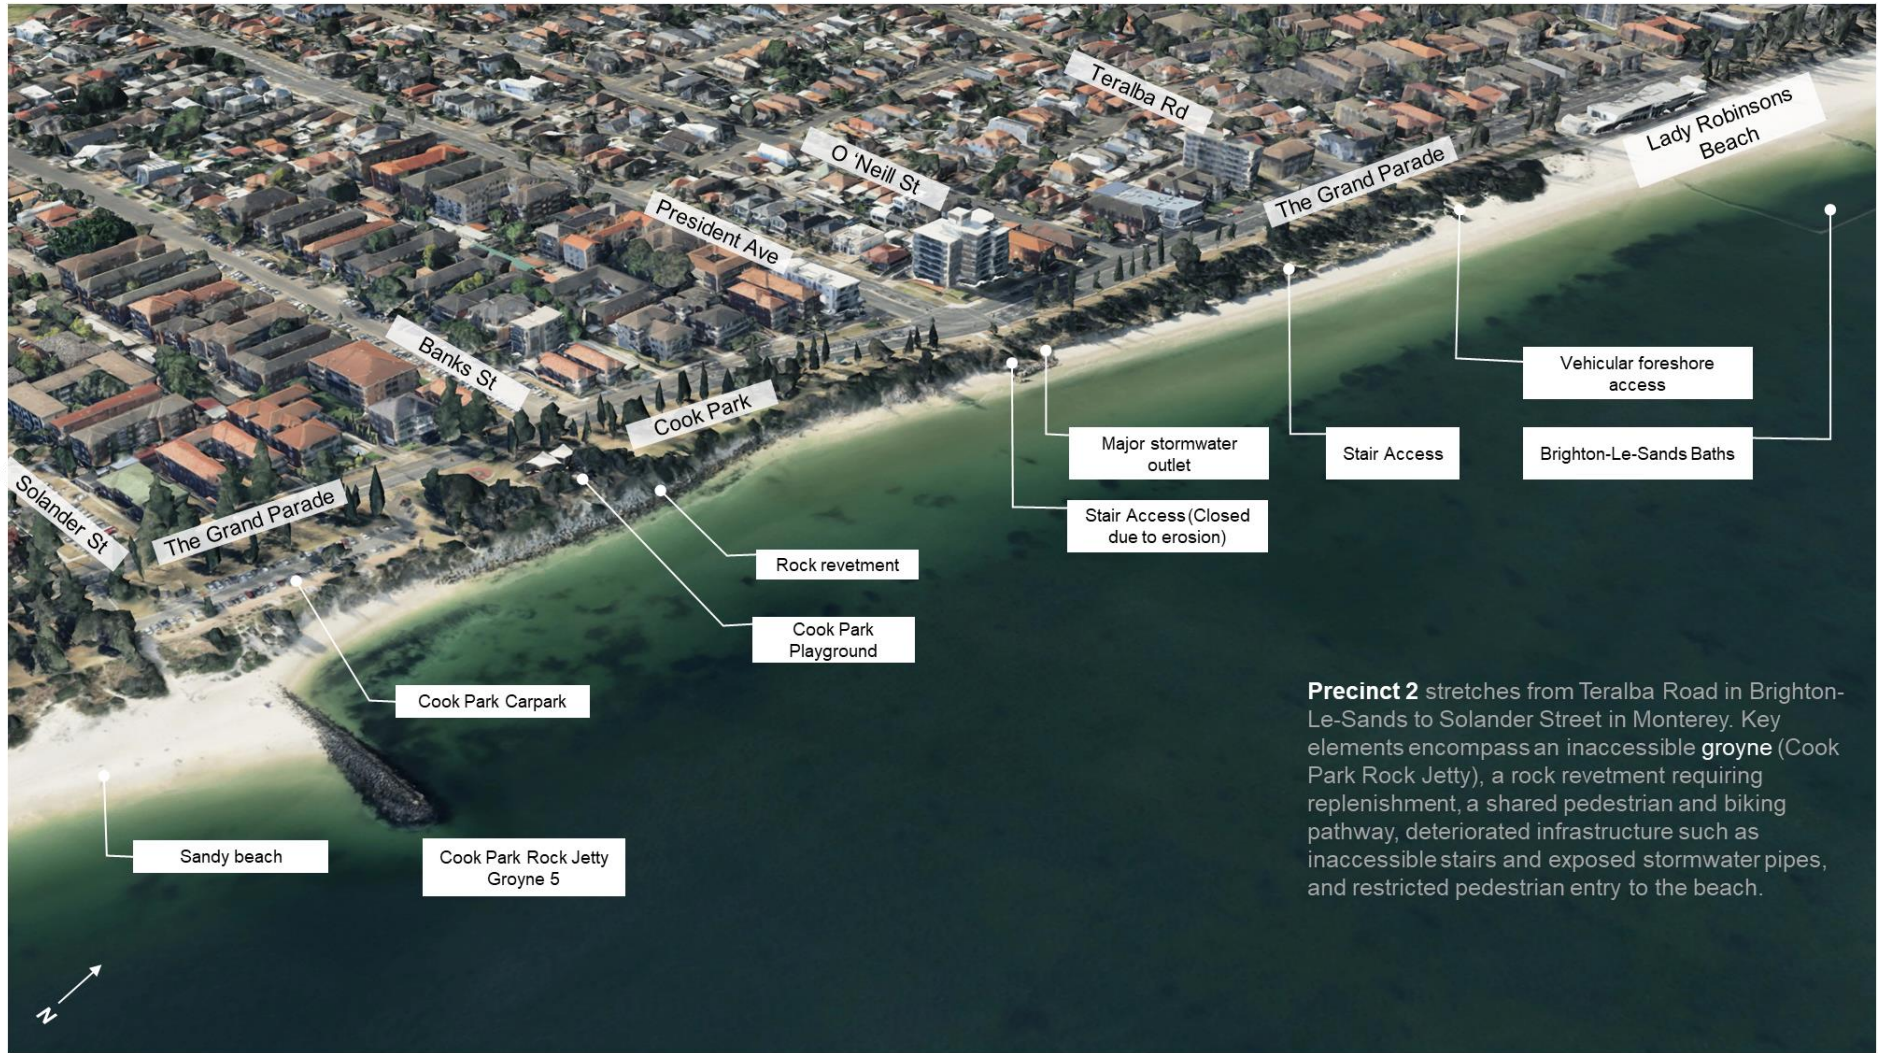
Figure 1.2: Precinct 2 Study Area - Teralba Rd (Brighton-Le-Sands) to Solander St (Monterey)

**Precinct 2** stretches from Teralba Road in Brighton-Le-Sands to Solander Street in Monterey. Key elements encompass an inaccessible groyne (Cook Park Rock Jetty), a rock revetment requiring replenishment, a shared pedestrian and biking pathway, deteriorated infrastructure such as inaccessible stairs and exposed stormwater pipes, and restricted pedestrian entry to the beach.

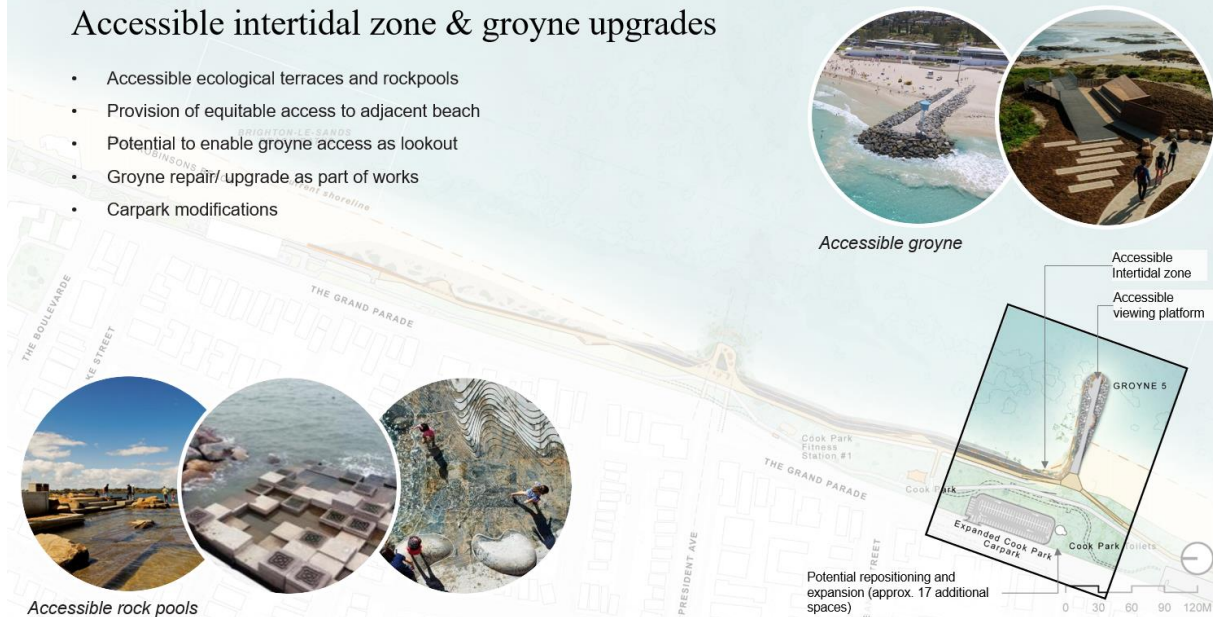
Figure 3.5: Southern region at Groyne 5 concept design plan

## Accessible intertidal zone & groyne upgrades

- Accessible ecological terraces and rockpools
- Provision of equitable access to adjacent beach
- Potential to enable groyne access as lookout
- Groyne repair/ upgrade as part of works
- Carpark modifications

- Accessible intertidal zone, groyne upgrades and improved beach access at Solander St (**Figure 3.5**). This area also includes the potential opportunity to reconfigure the existing carpark to allow for increased parking spaces (nom.18 spaces) with improved green buffer zone alongside the shared user path, improved accessibility to the public toilets and provision of increased public space (approx. 2500sqm).

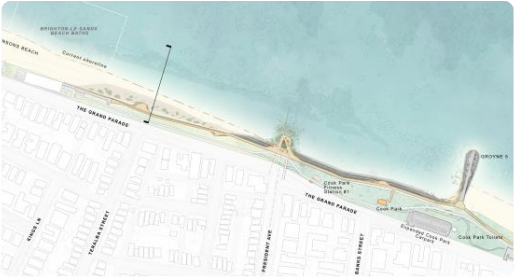
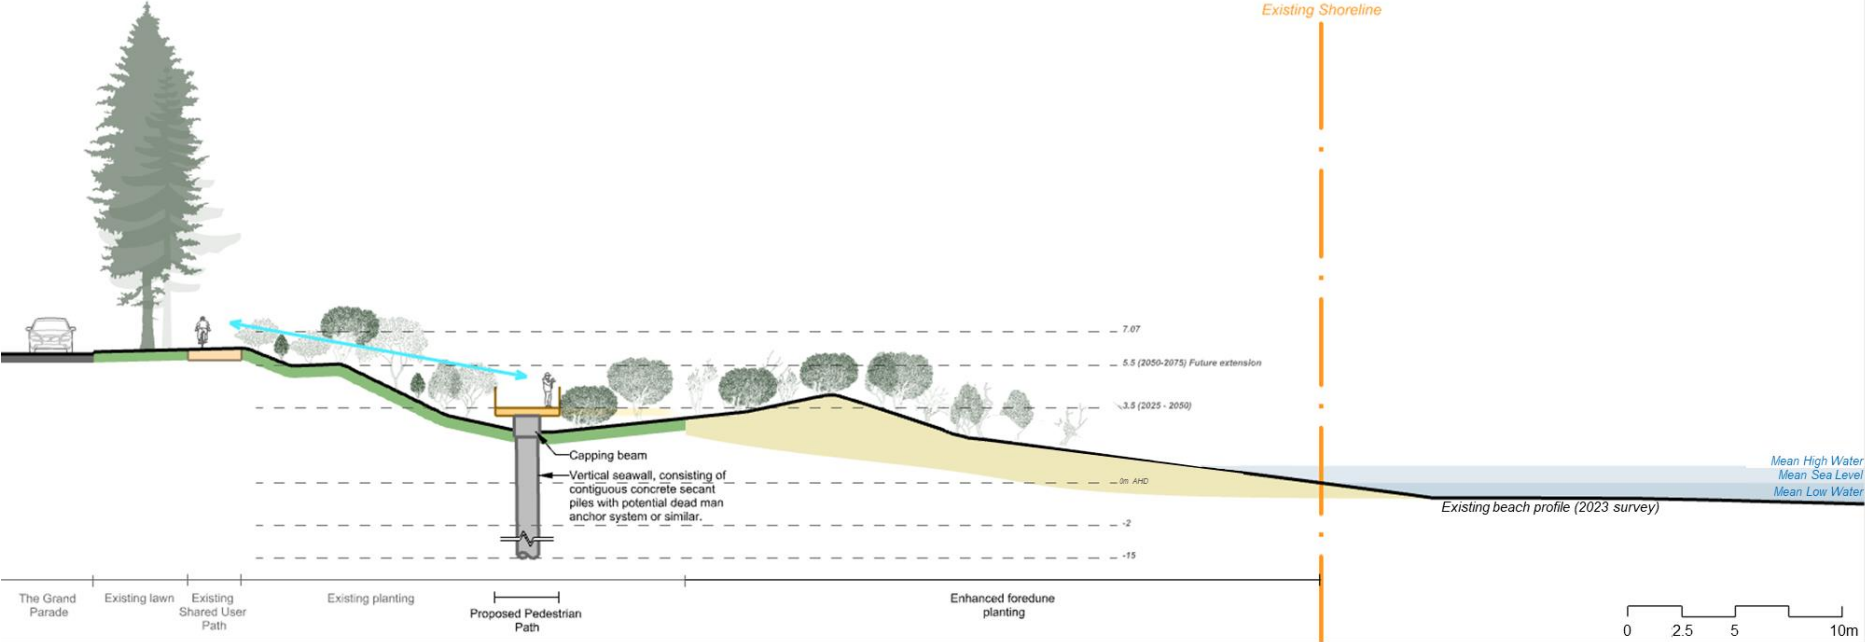
Figure 3.6: Northern region representative cross-section AA at Teralba Rd

# Typical Section AA

Vertical seawall with pedestrian path

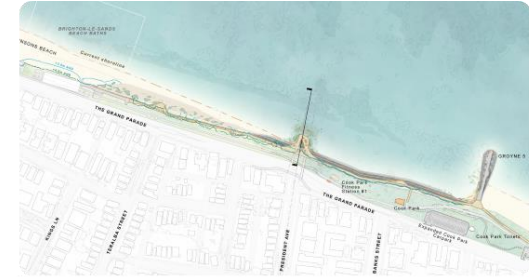
Figure 3.7: Mid region representative cross-section BB at President Ave

# Typical Section BB

Rock revetment wall with lookout at President Avenue

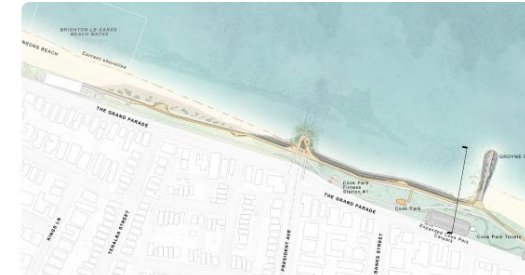
Figure 3.8: Southern region representative cross-section CC just north near Banks St

# Typical Section CC

Rock revetment wall with pedestrian path

**Figure 3.8** shows a representative cross-section (CC) of the engineered rock revetment with crest level pedestrian boardwalk at the southern end of Precinct 2 near Banks St. The rock revetment is designed with two-layers of randomly placed 0.3-3t (median armour mass,  $M_{50} = 2t$ ) igneous primary armour (1.6m layer thickness) with a 0.1-0.3t ( $M_{50} = 0.2t$ ) rock underlayer (0.75m thickness) and geotextile lining. The structure has a crest level (+4.0m AHD) pedestrian walkway and Dutch toe for scour protection with a nature-based designed intertidal zone. Initial crest levels are to be raised in a staged manner in accordance with an adaption plan with triggers for agreed risk thresholds for wave overtopping and sea level rise.

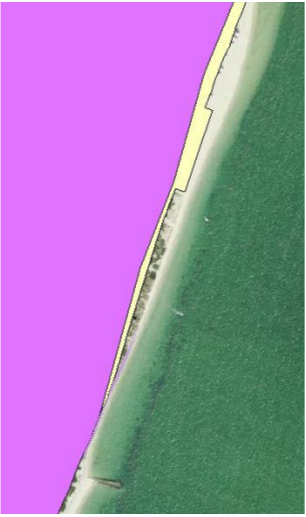
Environmental and social risks	Desktop searches	Risk description	Location	Environmental/social impact	Planning approval impact	Recommendation / Next Steps
Soils	eSpade/planning portal spatial viewer	Class 4 Acid Sulfate Soils (purple on screenshot) - likely to be found 2m below natural ground surface

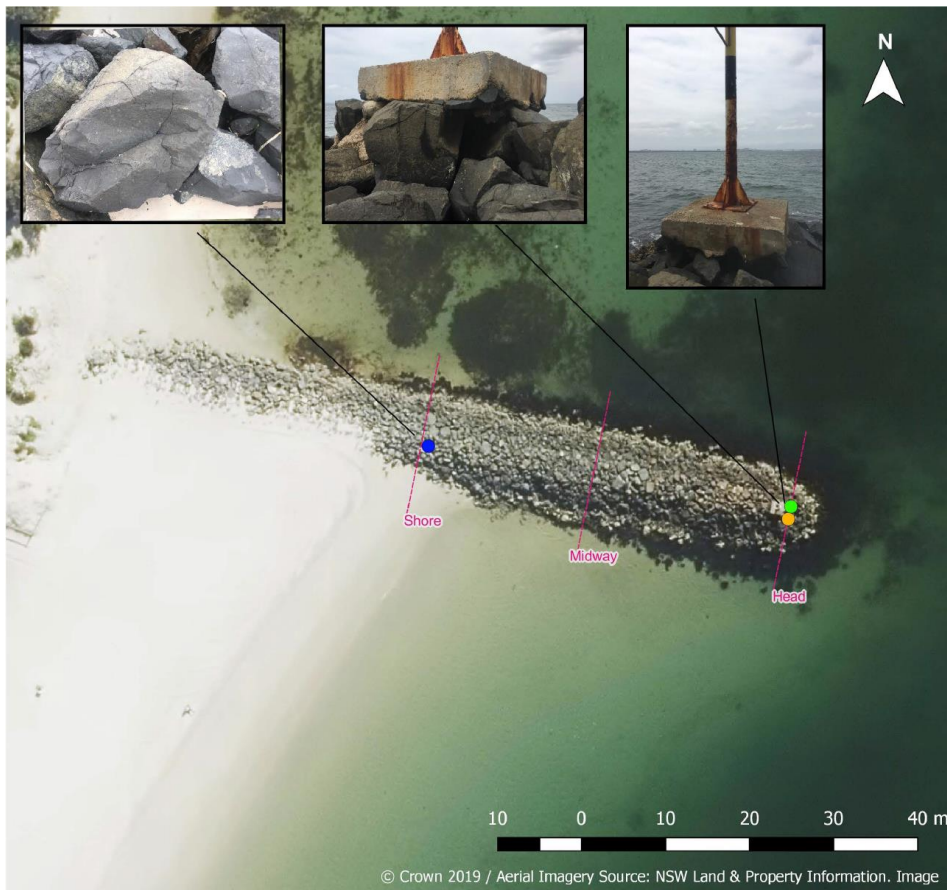
**Figure 5.4: Aerial image of Groyne 5 with assessment notes (From MHL, 2020)**

**Figure A.3**  
**Condition Inspection**  
**Groyne 5**

Results of condition assessment and survey of the structure by MHL in 2019 are shown in **Figure 5.4** and **Figure 5.5** (MHL, 2020). The overall condition of Groyne 5 was found to be *fair*, with defect observations and RTK-GPS surveys indicating that the primary rock armour layer was notably depleted at the head of the structure near the navigation post up to approximately 0.8m below the design crest level of 1.4m AHD, and equivalent to approximately a single layer of primary rock armour (rather than a double layer). The rocks have likely been displaced during large swell conditions and deposited at lower elevations (MHL, 2020).

Displacement of primary armour at the midway and shore survey sections was less significant. Undermining of the navigation post concrete footing was observed and corrosion at the base of the post itself. Hairline and fine cracks (<0.3mm) were noted in most rock armour units with slightly larger cracking (0.3 - 0.5mm) in some larger units (MHL, 2020).

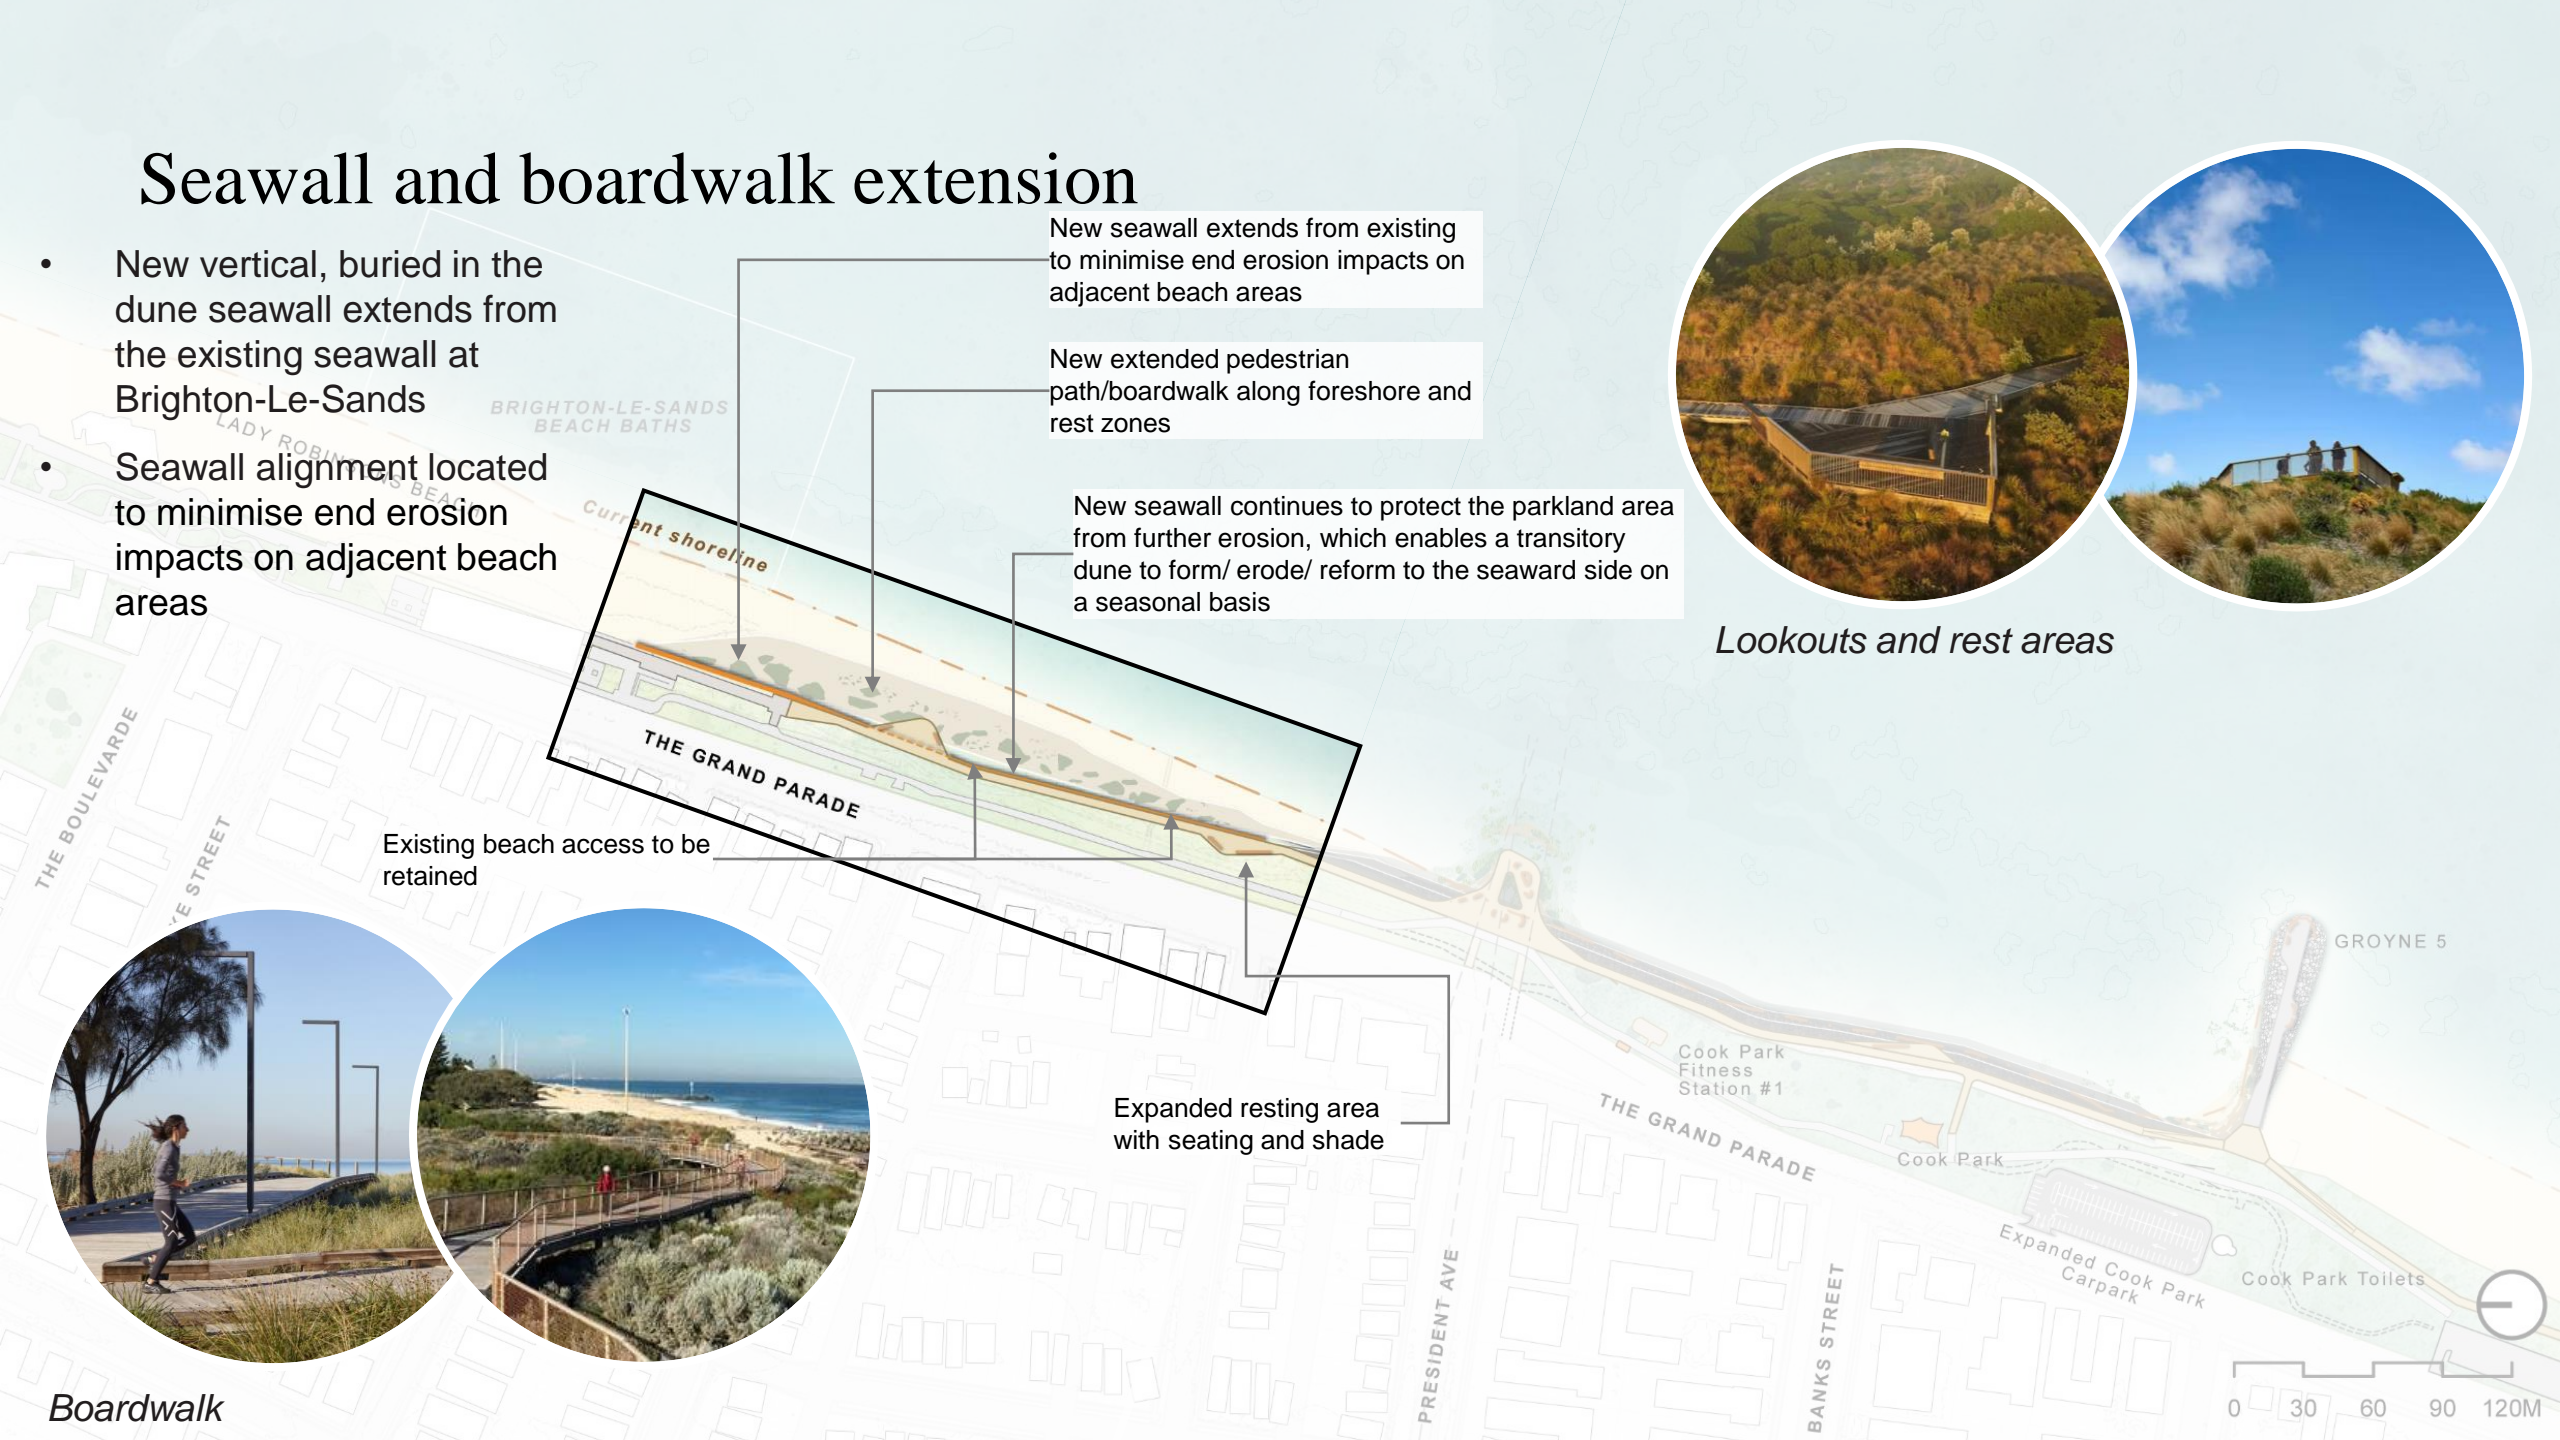
# Seawall and boardwalk extension

- New vertical, buried in the dune seawall extends from the existing seawall at Brighton-Le-Sands
- Seawall alignment located to minimise end erosion impacts on adjacent beach areas

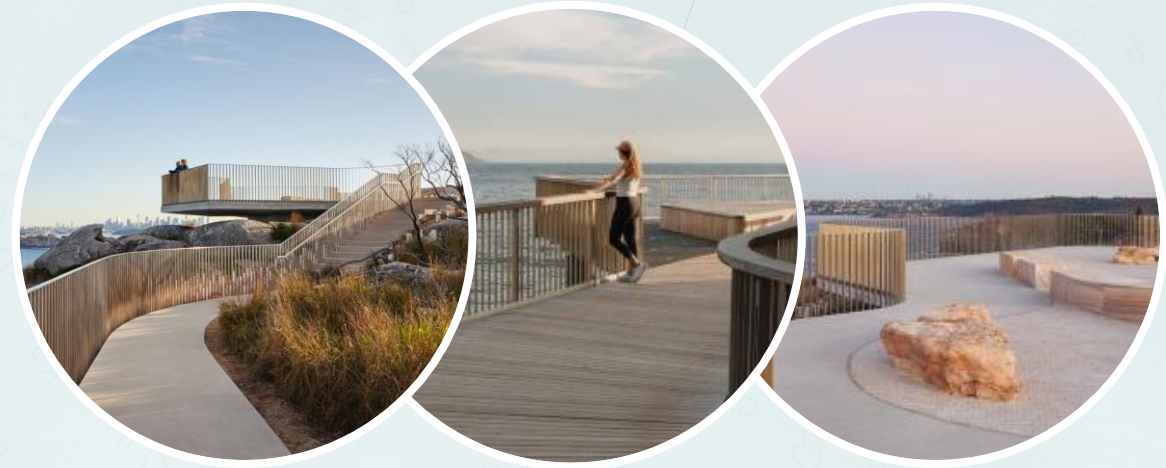
*Cantilevered lookout structure*

- Expanded public realm at current 'bottle-neck'
- Foreshore realignment at President Avenue to dissipate wave energy in most exposed/ at-risk area
- Introduce an intertidal aquatic reef and terracing to promote marine biodiversity, and enable public viewing (inaccessible)
- New look-out structure at President Avenue with views over bay, out towards heads and sunrise
- Realignment of shared user path (SUP) to pull back from hard road edge

It is noted that the concept design for Precinct 2 includes an over-water cantilevered platform constructed immediately to the south of the stormwater outlet, to provide a viewing platform and increase amenity of the foreshore at President Ave. This provides an opportunity to improve the form and function of the stormwater outlet. Subject to an assessment of the existing stormwater network, including the water quality of liquid flowing through the outlet, volume and type of potential pollutants etc., options for improvement may include in-line or off-line stormwater quality treatment devices, flow attenuation devices (e.g. “duck-billed valves”), energy dissipators, or other devices that improve the quality and/or amenity of the stormwater outlet.

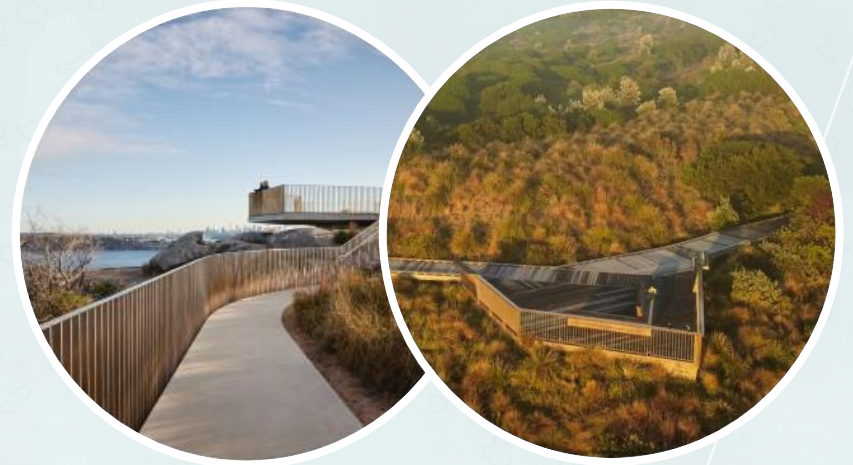
Boardwalk and lookouts

# Rock revetment with boardwalk

- Continued engineering rock revetment with nature-based intertidal zone
- Relocated walking path along foreshore edge
- Opportunity for expanded seating area

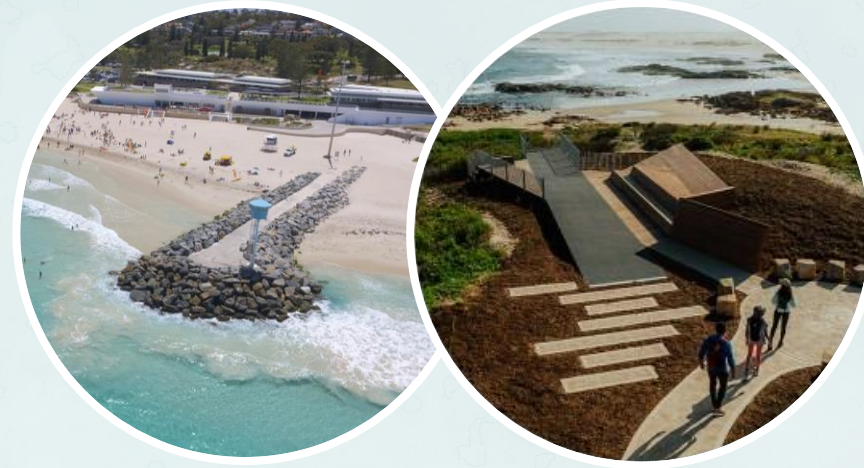
Accessible groyne

# Accessible intertidal zone & groyne upgrades

- Accessible ecological terraces and rockpools
- Provision of equitable access to adjacent beach
- Potential to enable groyne access as lookout
- Groyne repair/upgrade as part of works
- Carpark modifications

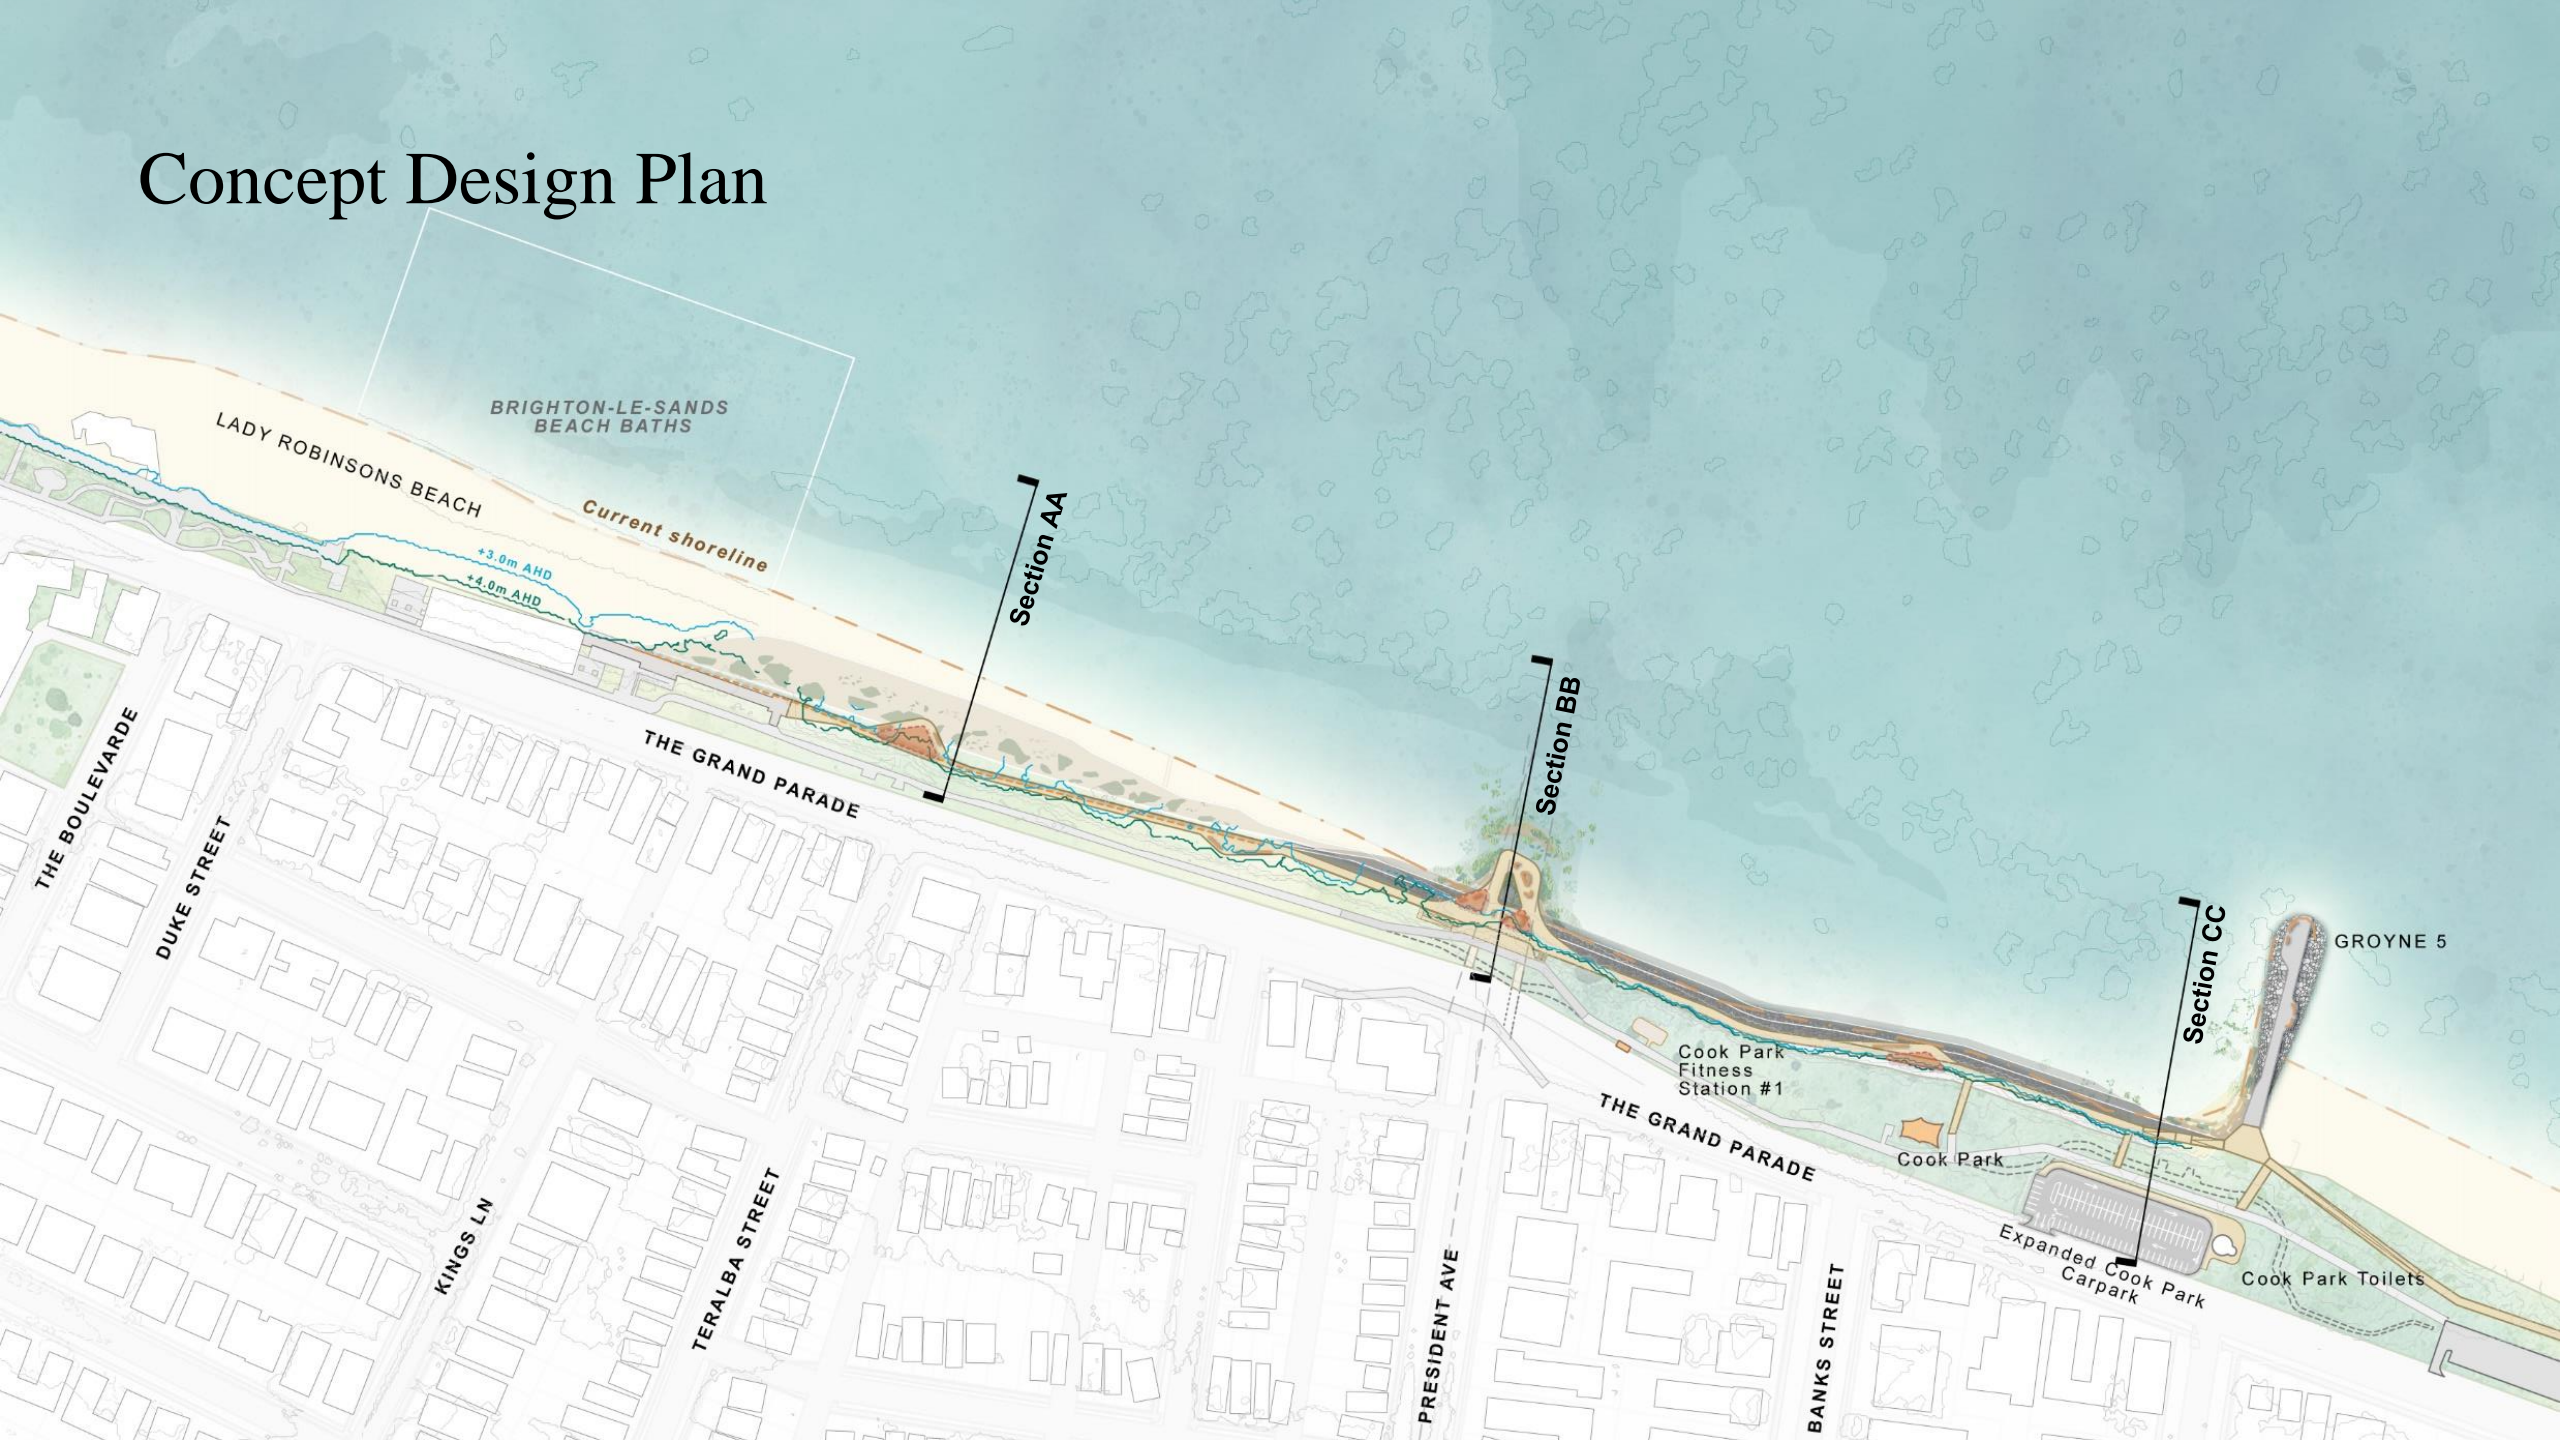
# Concept Design Plan

1. New buried vertical seawall with foreshore boardwalk terminating at existing seawall at Brighton-Le-Sands
2. New lookout platform and artificial rock reef providing wave energy dissipation and supporting ecological outcomes
3. Nature-based designed intertidal zones
4. New engineered rock revetment with waterfront promenade and nature-based designed intertidal zone
5. Enhancements to existing groyne (added rock and amenity improvements)

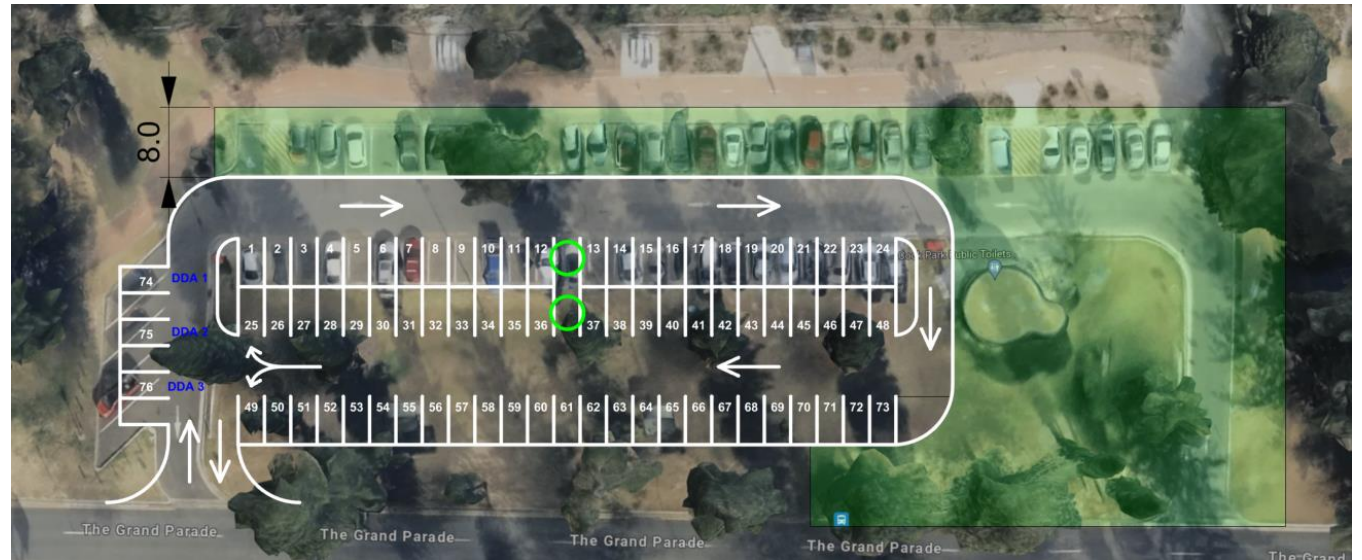
As part of the foreshore upgrade works, there is an opportunity to reconfigure the existing carpark. As part of this study, a preliminary testing has been undertaken (see plan right). To confirm this approach, further design work is required in the next stage. The preliminary option (right) demonstrates the following benefits:

- Increased parking spaces (nom.18 spaces)
- Green buffer zone alongside the shared user path
- Improved accessibility to the public toilets and provision of increased public space (approx. 2500sqm)
- Rationalisation of vehicular access points to singular crossover

Existing configuration: approx. 59 spaces (approx.):  
Reconfigured design: 76 Spaces (73 Standard; 3 DDA)

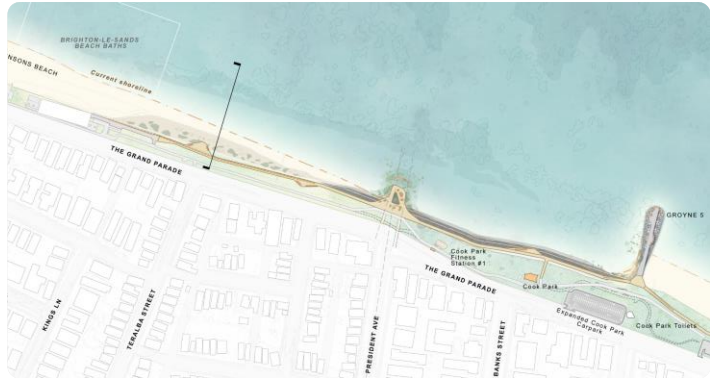
# Typical Section AA

## Vertical seawall with pedestrian path

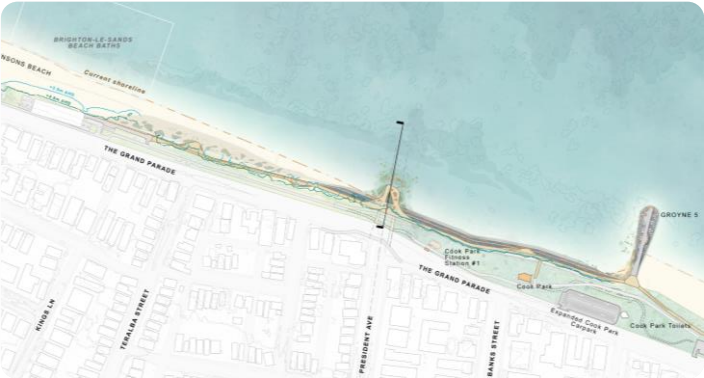
# Typical Section BB

## Rock revetment wall with lookout at President Avenue

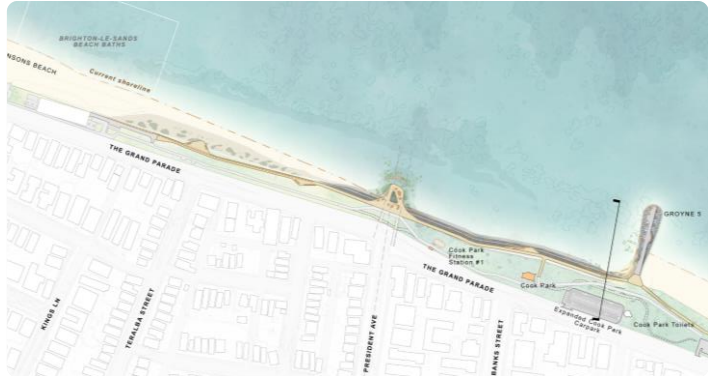
# Typical Section CC

## Rock revetment wall with pedestrian path

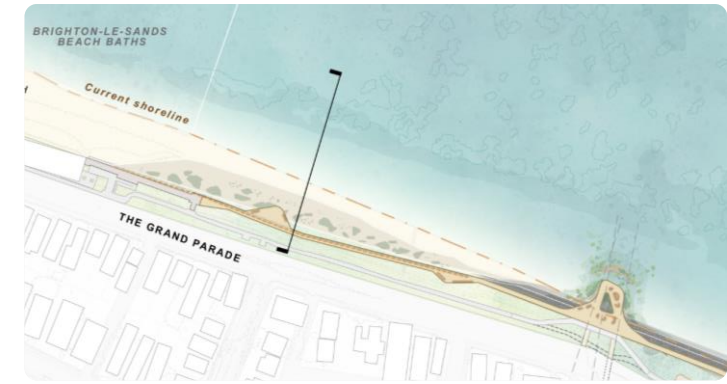
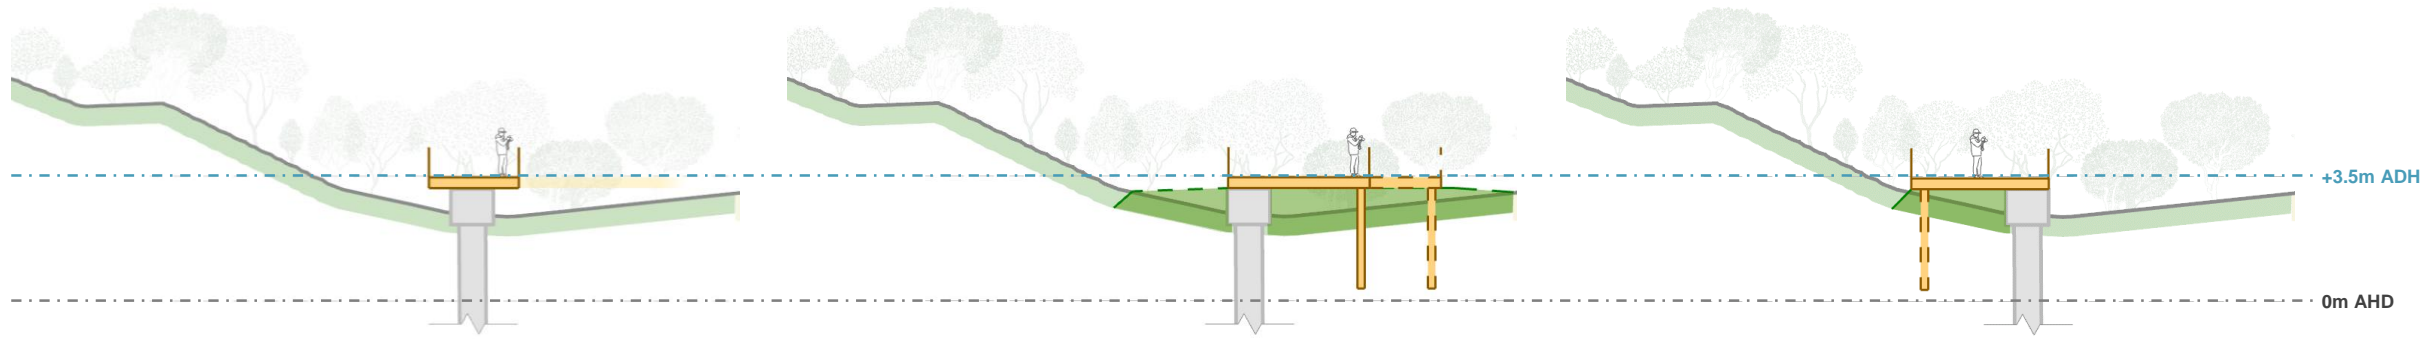
Typical Section AA | Crest height: +3.5m AHD

# Pedestrian alignment on vertical sea wall

## 1 Pedestrian path *on* vertical seawall

- Path sits on top of sea wall
- Landscape infilling is optional

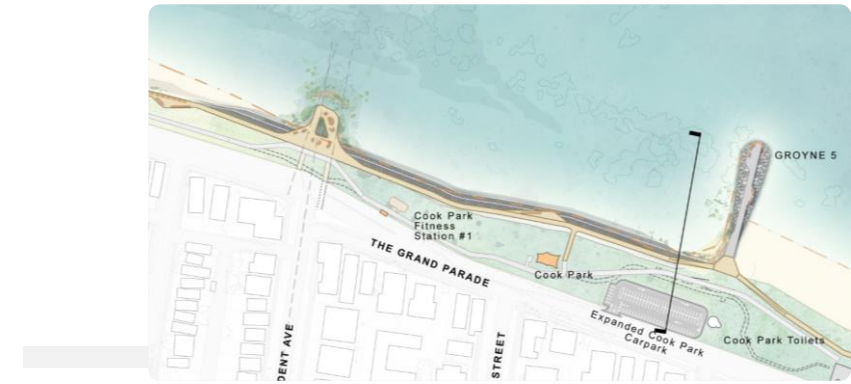
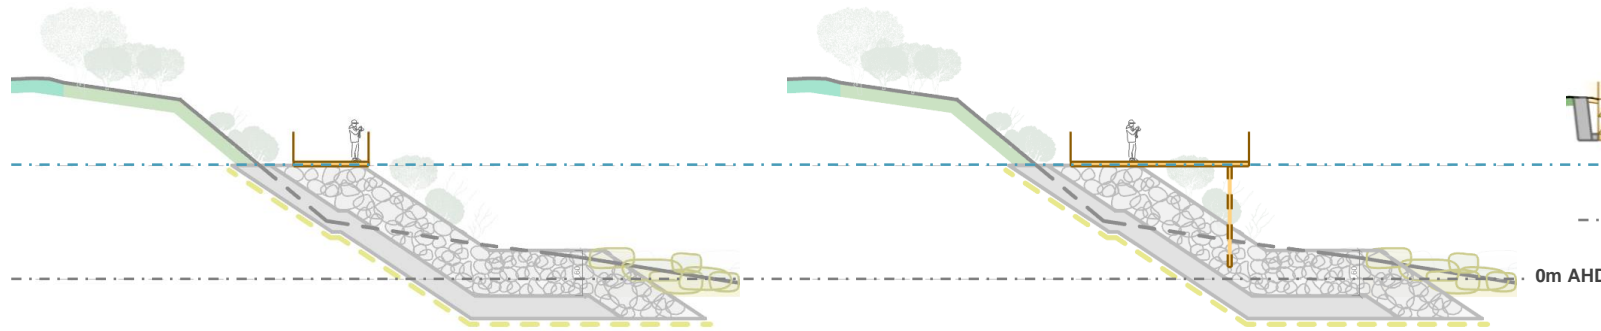
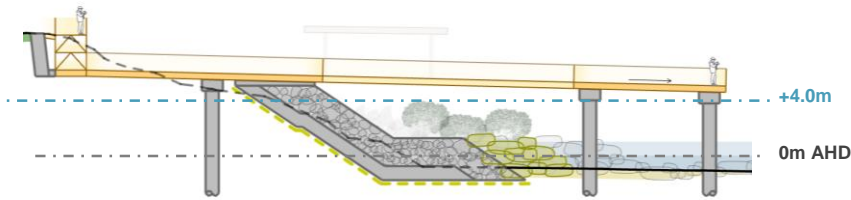
Typical Section CC | Crest height: +4.0m AHD

# Pedestrian alignment on rock revetment

## 4 Pedestrian path on rock revetment

- Path sits on top of sea wall
