# Precinct 2 Concept Design: Teralba Rd (Brighton-Le-Sands) to Solander St (Monterey)

## LADY ROBINSONS FORESHORE MANAGEMENT PLAN

Report MHL3034

Prepared for: Bayside Council

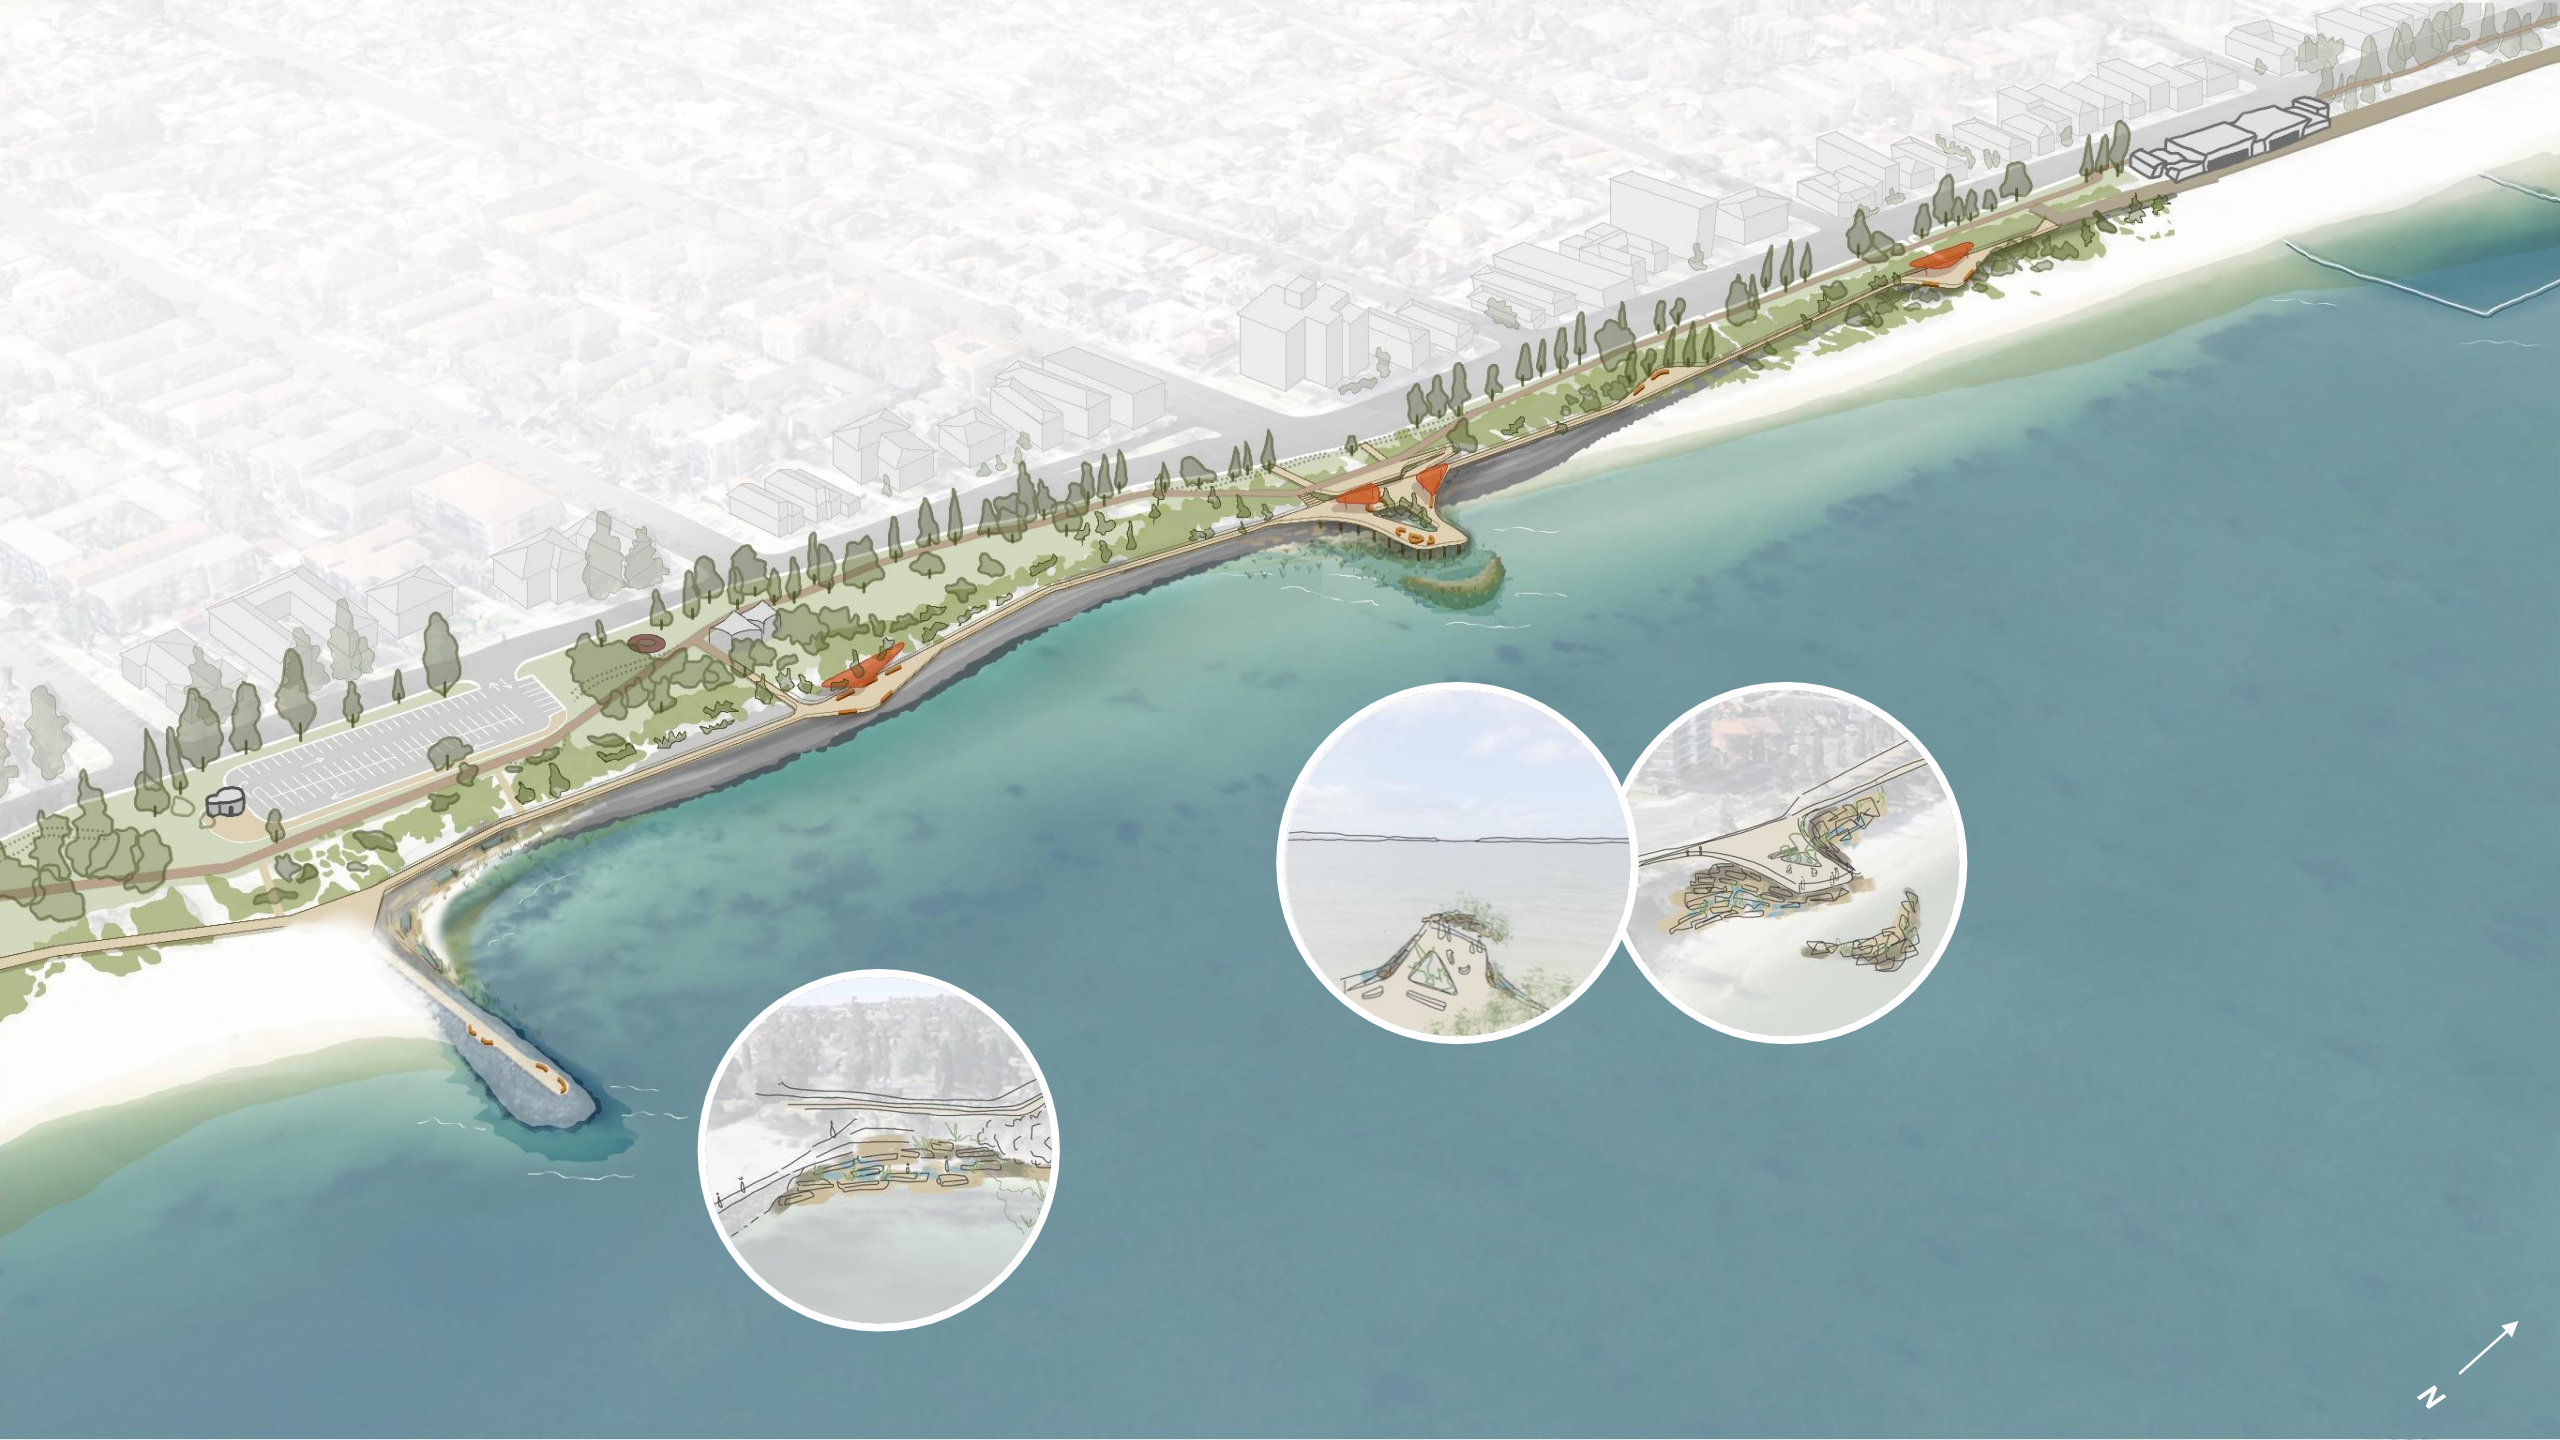
## 2 Pedestrian lookout at President Avenue (Section BB)

- **Position: Seaward**
- DDA accessible ramp from street level to lookout
- Path sits on existing landscaping
- Piling and excavation will be required

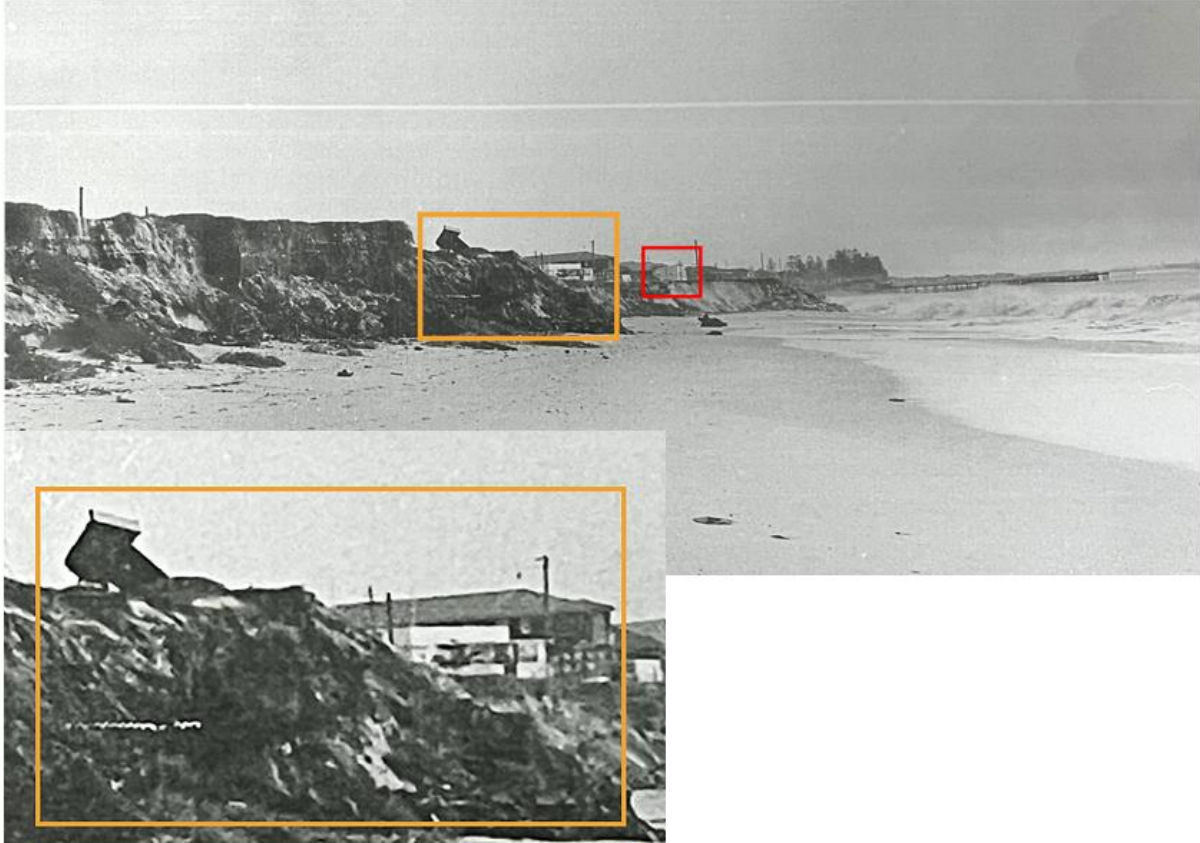
Figure B.0.1: Significant erosion of Lady Robinson Beach circa 1967. Note the presence of tipper truck demarcated in orange, likely 'placing' rock along the foreshore as a form of ad-hoc coastal protection works. Note also prominent building on The Grand Parade demarcated in red. Image source: Council

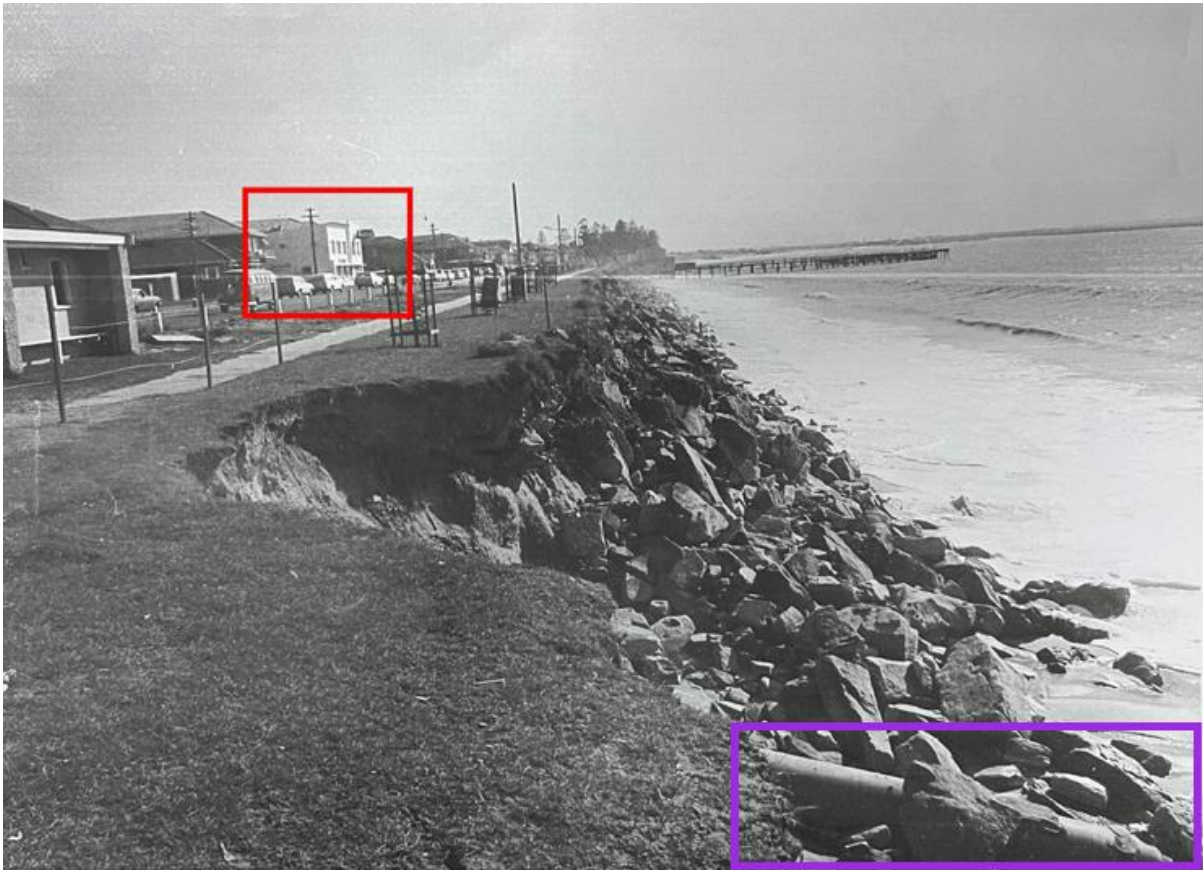
**Figure B.0.2: Rock ‘placed’ along the foreshore at Lady Robinsons Beach as ad-hoc coastal protection works circa 1967, with broken stormwater pipe demarcated in purple. Note prominent building on The Grand Parade demarcated in red. (Image source: Council, provided to MHL, 2024)**

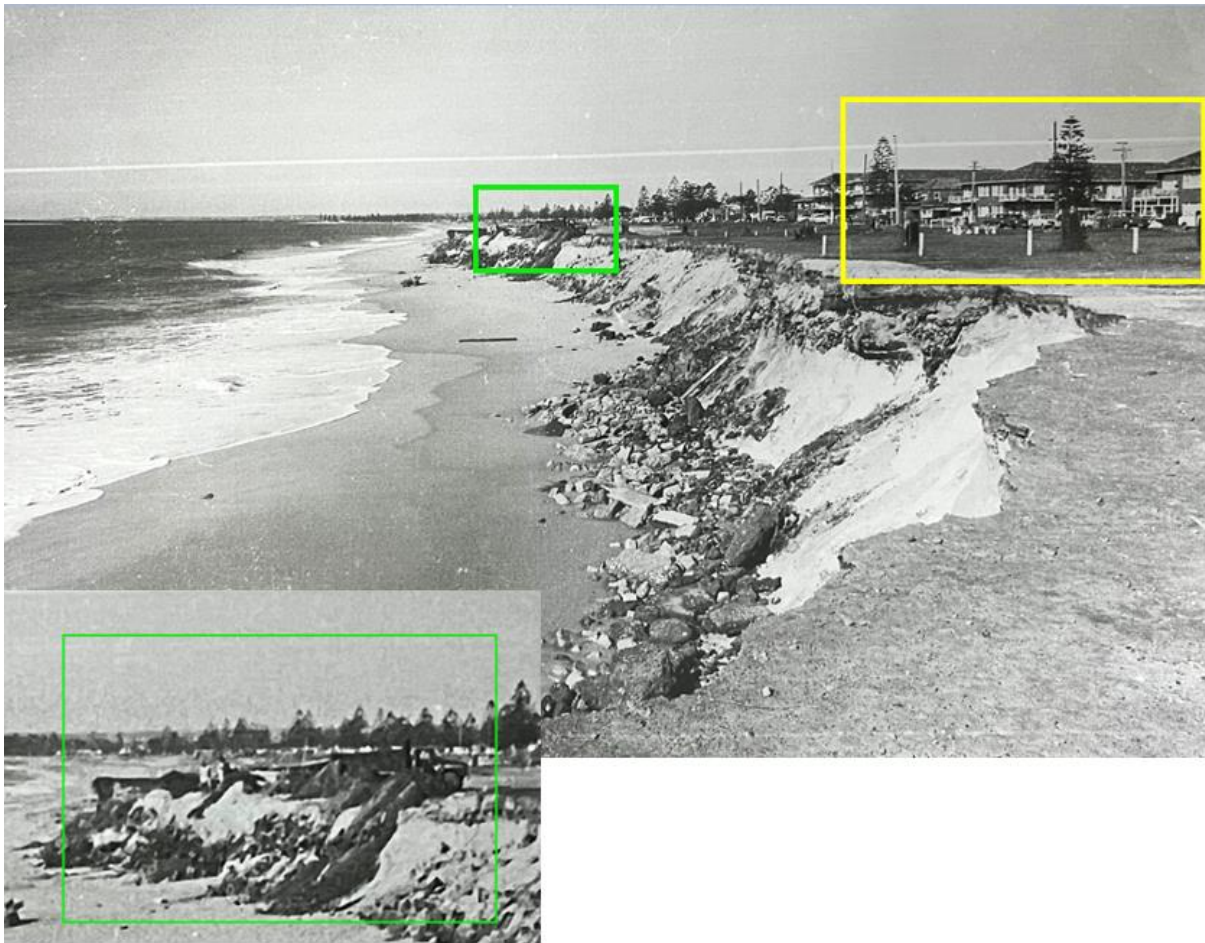
**Figure B.0.3: Erosion of Lady Robinson Beach circa 1967, view towards the south. Note the presence of a truck at the dune scarp demarcated in green within the primary image, as well as the magnified image (inset), and residential properties demarcated in yellow, providing a reference point for estimated spatial placement of rocks as ad-hoc coastal protection works circa 1967 (source: Council, provided to MHL, 2024)**
